Energy Study and Net Zero Strategy

Prepared for
**Village of Midway
Community Hall**

Prepared by:
SES Consulting Inc.
Suite 410 – 55 Water Street
Vancouver, BC V6B 1A1
Tel: 604.568.1800
www.sesconsulting.com

October 15, 2013
Updated August 31, 2016

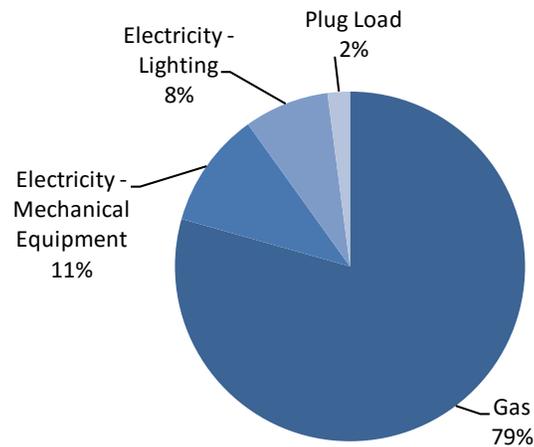
Annual Utility Consumption

With a high level analysis of utility bills and facility equipment, the following breakout of energy consumption is produced:

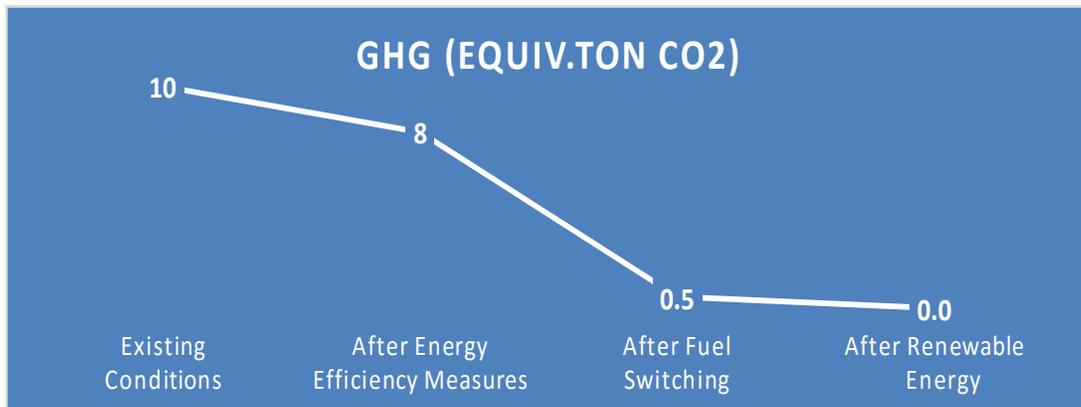
The facility currently produces 10 tonnes of equivalent annual CO₂ emissions. The following chart demonstrates how emissions can be brought to zero, saving the complete energy utility cost of \$3,300 annually plus \$1,200 in potential additional revenue from surplus onsite electricity generation.

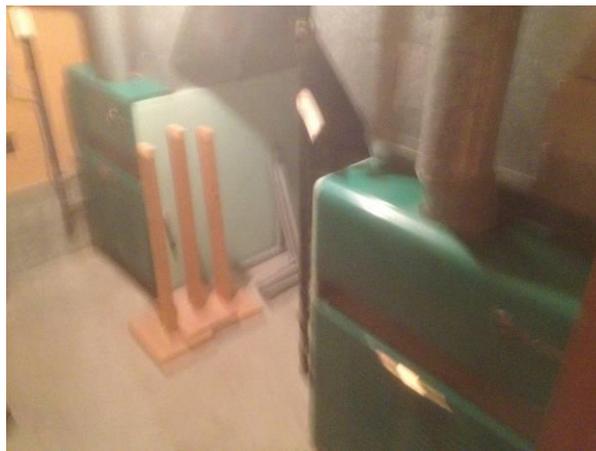
Figure 1: Low Efficiency Furnaces

There are two natural gas furnaces located on the mezzanine that serve the main floor and basement. The furnaces are well past their expected life and should be replaced. Many of the individual rooms have locally controlled electric baseboards to provide additional heating; these units are not interlocked with any of the other systems leading to the occurrence of overheating in all the zones visited on the day of the site tour.

These gas furnaces are past the expected service life. They are about 40 years old and present a risk to catastrophic failure. The efficiency of a furnace of this age is less than 60%.

Heat pump technology can surpass 600% efficiency in ideal conditions, and never falls below 100%. For comparison, a new condensing gas boiler operates at 80-95% efficiency while the existing gas furnaces are estimated to operate around 65% efficiency. Air source heat pumps are rapidly gaining traction in the Canadian HVAC industry. They use an outdoor evaporating unit to capture heat and reject it to a condensing coil indoors. The latest generation of this technology is rated to outdoor temperatures of minus 30 Celsius. For the Midway Village climate, we recommend coupling the heat pump system with an electrical booster (resistance heating) to ensure full heating capacity is available during the coldest times of the winter.

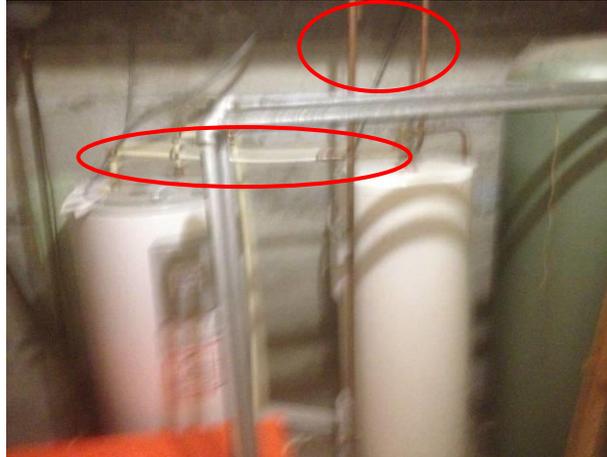
Figure 2: Un-insulated piping

The Domestic Hot Water is supplied by a two electric water heaters about 187 litre, 3,000 W each. The DHW piping is exposed and can be insulated; also a heat trap could be installed to reduce convection losses.

Mechanical Upgrades include air infiltration sealing and hot water pipe insulation. Ensuring that building envelop penetrations are sealed and water tight will reduce loss of heated air in winter. Replacing door seals and window caulking on a regular basis will improve the overall performance of the heating system and reduce drafts in the occupied spaces. The exposed DHW piping should be insulated to minimize unwanted heat loss into the surrounding space.

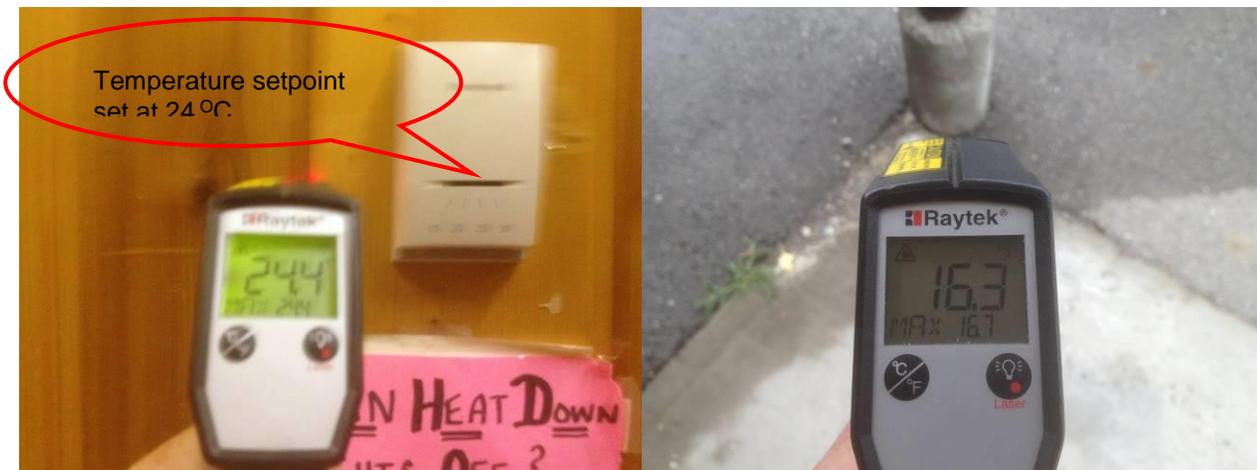
Figure 3: Indoor and Outdoor Temperature, Heat ON in Summer

The building was in heating mode because of the low night time temperatures that frequently occur during the summer months in mountain regions. The furnaces and electric baseboard come on at night when the outdoor air temperature is at 11°C, which is about 5°C below the setpoint for bringing on the heating systems. This causes the building to be preheated on a day when day-time temperatures are going to be in the high 20 to low 30°C range. This gap in the control system sequence of operations is making the building uncomfortably warm during the day.

Specific strategies to be implemented with the BAS upgrade include reduced schedules with weather prediction and optimal start, advanced warm-up, outdoor air lockout, nighttime setback sequences, and eliminating heating and cooling conflicts. This will address the chronic over heating of some of the offices.

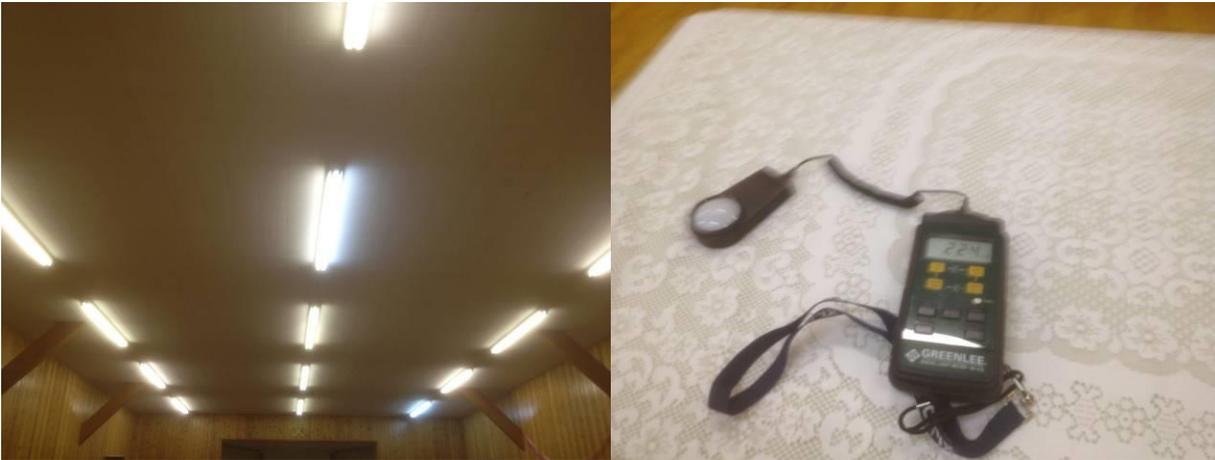
Figure 4: T12 Lamps Requiring Replacement

Lighting systems in the building is predominantly obsolete fluorescent T12 with magnetic ballasts, and screw in CFLs or incandescent lamps. The lighting is controlled by room wall switches.

The main floor would be over lit if the lamps were not degraded by being at the end of their life. When these lamps are replaced the light levels will be excessively high for the area, so delamping is recommended in conjunction with a lighting upgrade.

Lighting Upgrades primarily revolve around replacing the obsolete T12 fixtures with new, TLED technology. Also replacement of existing incandescent and CFL lamps with LED screw in lamps. Additionally, de-lamping should be done in areas where the current lighting levels are in excess of those required for the space.

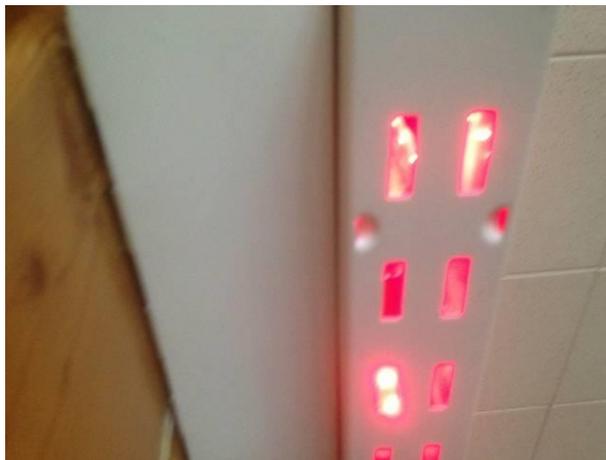
Figure 5: Existing LED Upgraded Exit Lights

The exit lights have been upgraded to LED, as have some exterior lights.

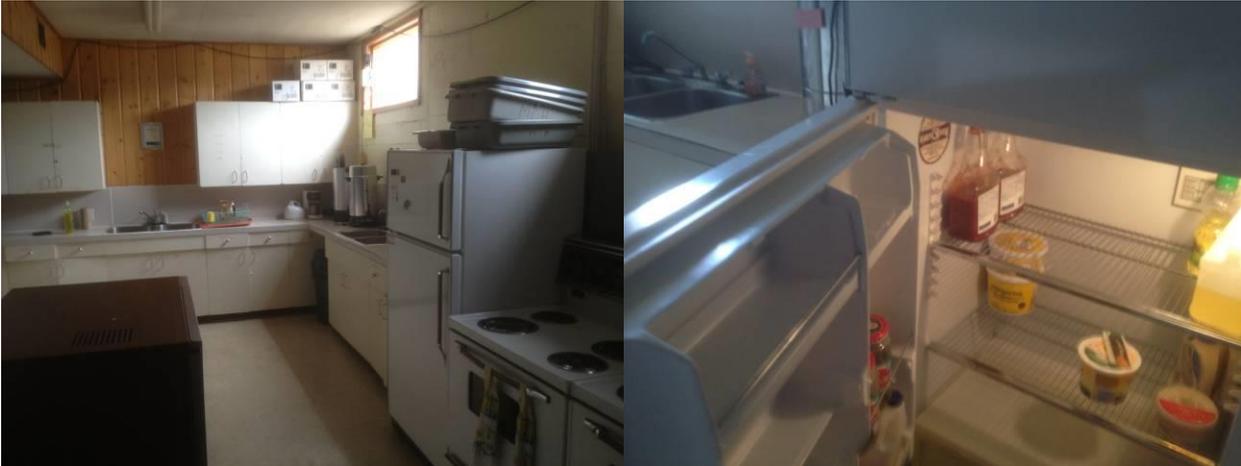
Figure 6: Plug Load in Basement Kitchen

Major plug loads consist of the kitchen refrigeration equipment being left on when not in use.

Occupant Engagement involves social campaigning to reduce unnecessary electrical plug load. Energy efficiency strategies will be far more effective if building occupants are included in the process in a series of communications to encourage energy awareness behavior. We highly recommend an occupant engagement strategy be put in place in order to educate building occupants on the ideas and options for energy conservation in this facility, such as closing window blinds when leaving a room as well as turning out the lights. Research highlights that occupant engagement enables positive outcomes and culture change that encourages energy efficient behavior.

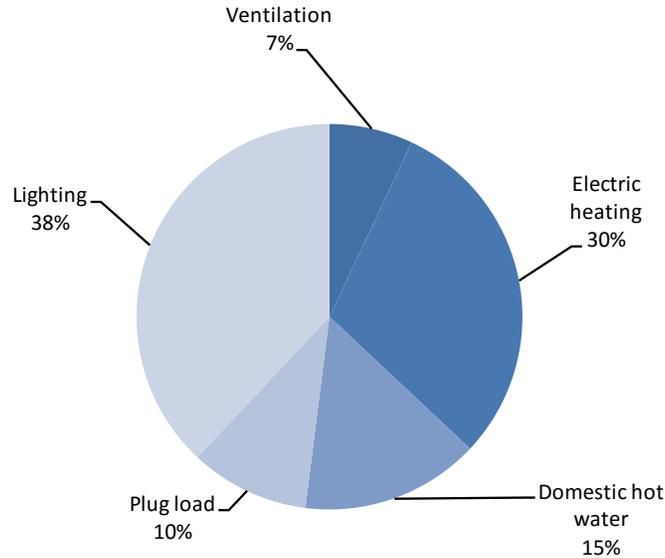
Figure 7: Community Hall Electricity Consumption

The estimated percentage of electricity consumption by building system is presented in Figure 7. This ballpark breakdown is based on very rough estimates based on a thorough site visit and our past experience with similar facilities. These values have been used to estimate savings from measures associated with these systems.

We estimate that largest end uses of electrical energy in the building are lighting, domestic hot water heating, ventilation, and electric heating, using 38%, 15%, 7% and 30% of consumption each. Plug load makes up the remainder of the load at 10%.

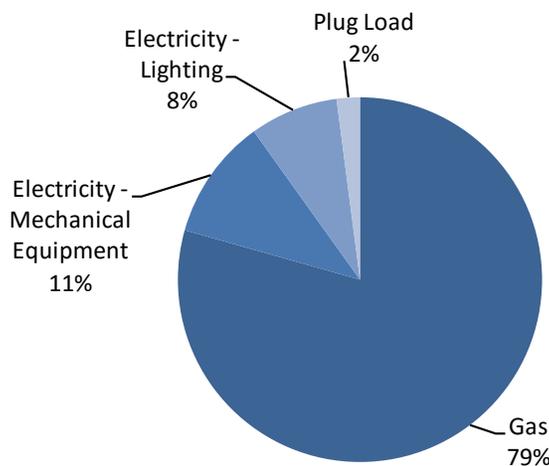
Figure 8: Community Hall Electricity and Gas Consumption

The estimated percentage of total energy consumption by building system is presented in Figure 8. Gas heating energy consumption makes up the majority of energy use in the building at 79% of overall energy consumption, followed by electric lighting at 8%. Mechanical Equipment followed by plug load make up 11% and 2% respectively.

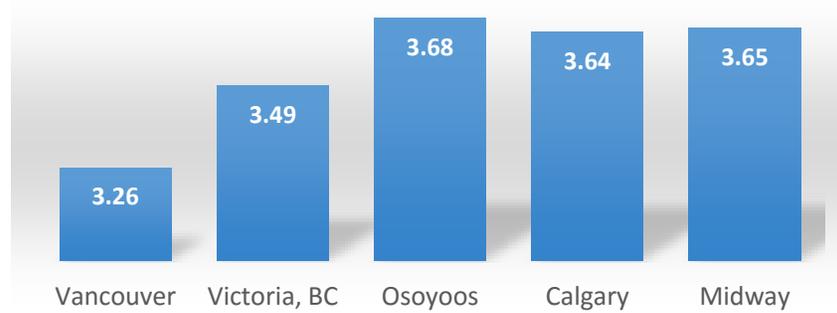
Figure 9: Horizontal Solar Irradiation (KWh/m²/day)

A solar photovoltaic system represents the most cost effective method of renewable electrical generation at this scale. Our analysis budgets for 180m² of roof coverage, accounts for experimentally observed system losses, and uses the National Resources Canada (NR Can) published annual horizontal solar irradiation value of 3.65 KWh/m²/day for the Village of Midway. This can be compared to other nearby cities in Figure 9.

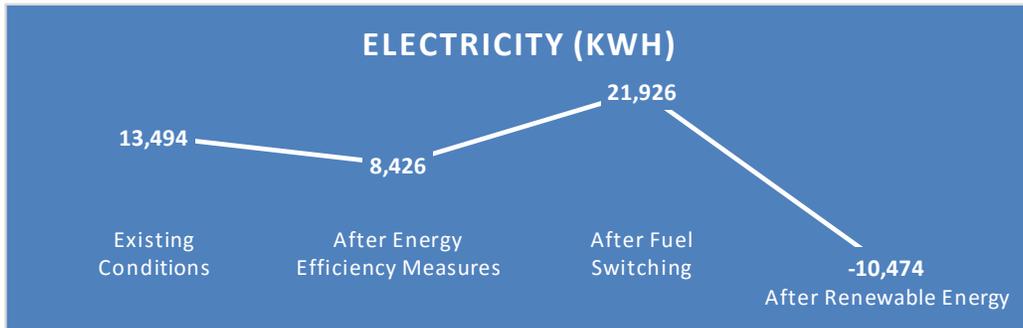
Figure 10: Potential Progression of Electrical Consumption

Should all the measures identified in this report be implemented, to a total of approximately \$206,000, the following graphs present the progression of energy savings and improvement of environmental performance.
